# GROUP F

**EXPLODED VIEW: ENCLOSURE C2****DRAWING #: 0G1145****GROUP F****APPLICABLE TO:**

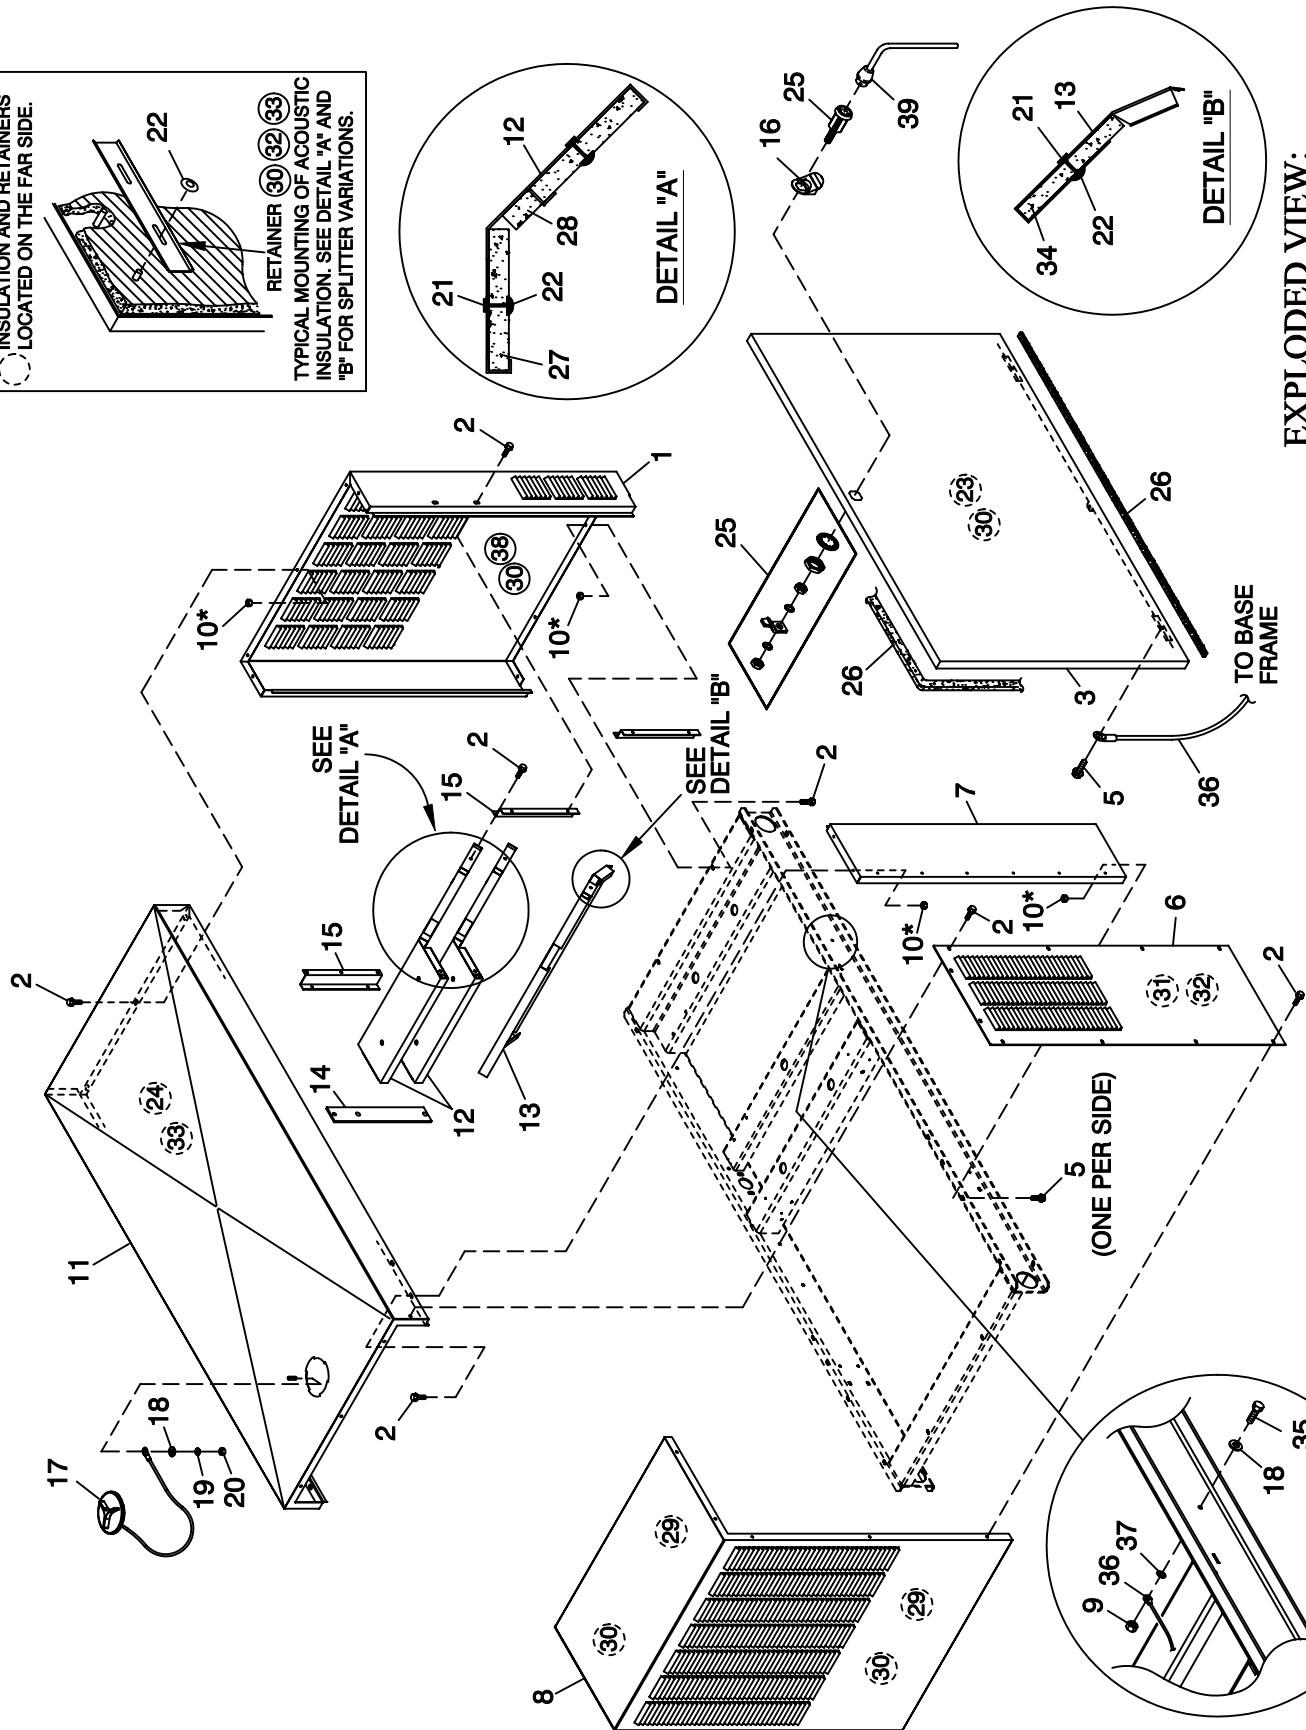
\* ALUMINUM ENCLOSURE NOTE: ALL ENCLOSURE PANELS THAT FASTEN TO THE BASE FRAME MUST BE SECURED USING ITEM 2 & 5 THREAD FORMING FASTENER AND ITEM 39 LOCK NUT. LOCK NUT IS TO BE INSTALLED AFTER THREAD FORMING FASTENER HAS PENETRATED THROUGH EXTRUSIONS IN ENCLOSURE PANELS. ALL ROOF PANELS ARE TO BE SECURED IN THE SAME MANNER.
