# GROUP F

**EXPLODED VIEW: ENCLOSURE C2****DRAWING #: 0G1145****GROUP F****APPLICABLE TO:**

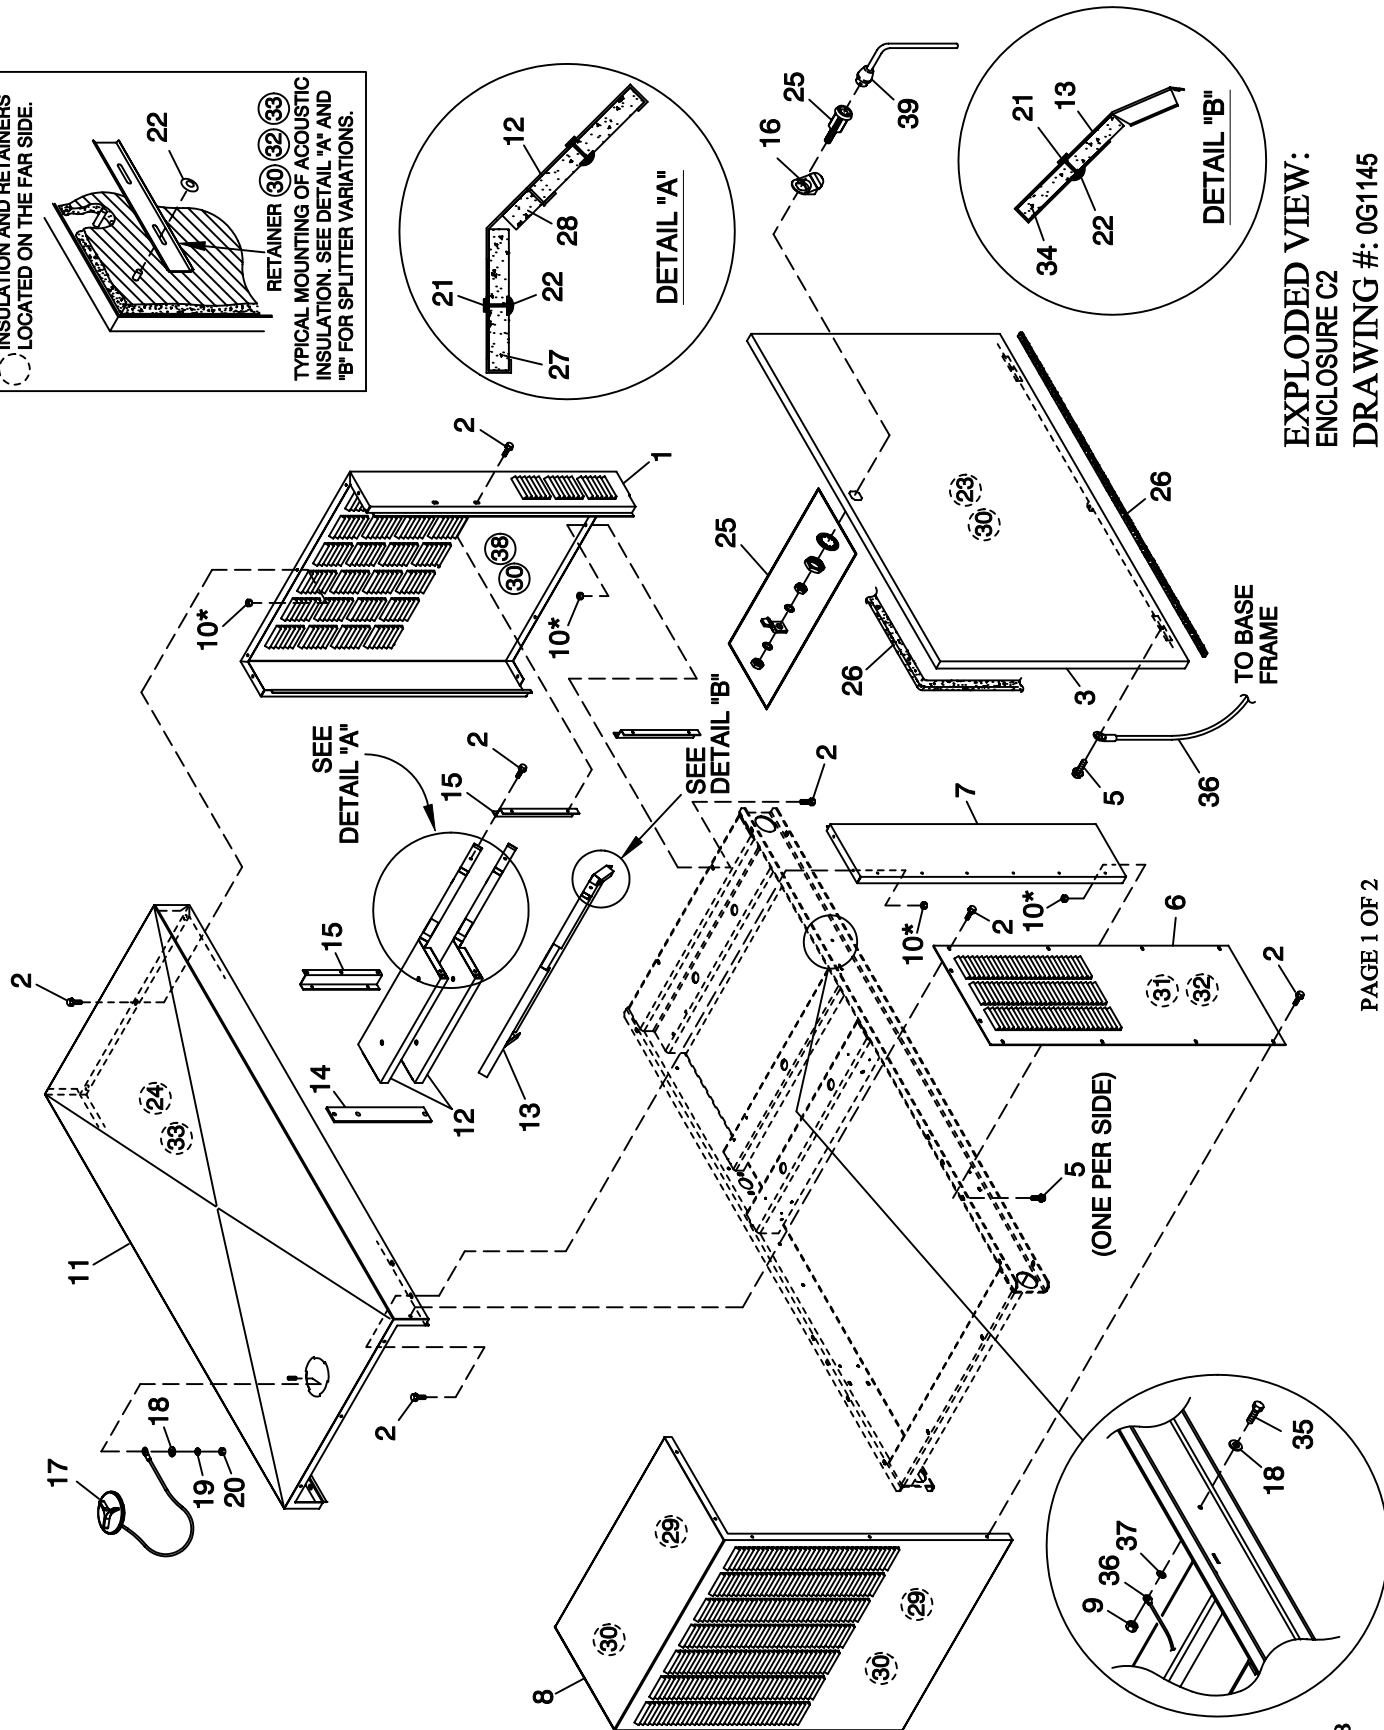
| ITEM | PART # | QTY. | DESCRIPTION |

\* ALUMINUM ENCLOSURE NOTE: ALL ENCLOSURE PANELS THAT FASTEN TO THE BASE FRAME MUST BE SECURED USING ITEM 2 & 5 THREAD FORMING FASTENER AND ITEM 39 LOCK NUT. LOCK NUT IS TO BE INSTALLED AFTER THREAD FORMING FASTENER HAS PENETRATED THROUGH EXTRUSIONS IN ENCLOSURE PANELS. ALL ROOF PANELS ARE TO BE SECURED IN THE SAME MANNER.
